Chapter A

Restoration by Record Measurement, Nevada

History of Surveys

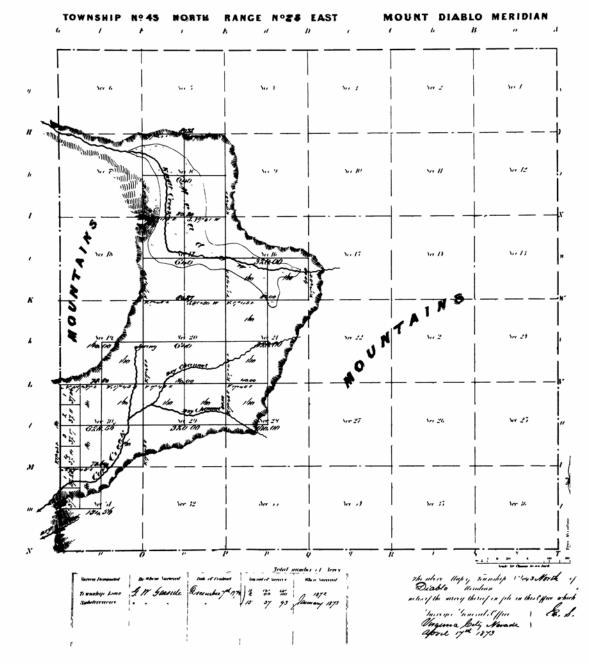
Figure 1 - Portion of 1873 Plat

1873 A portion of the subdivisional lines were surveyed by Garside in January 1873, as shown on the plat approved April 17, 1873, figure 1. The remainder of the subdivisional lines are unsurveyed.

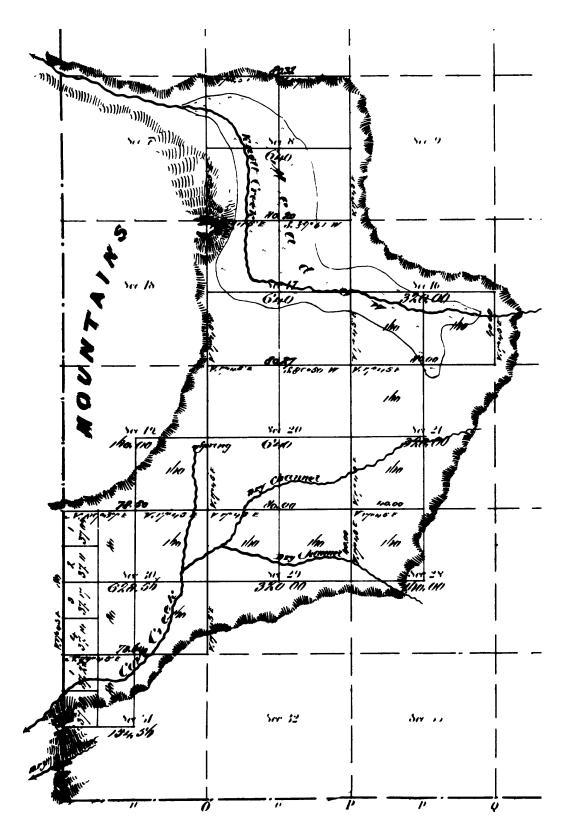
Figure 1 - Detail

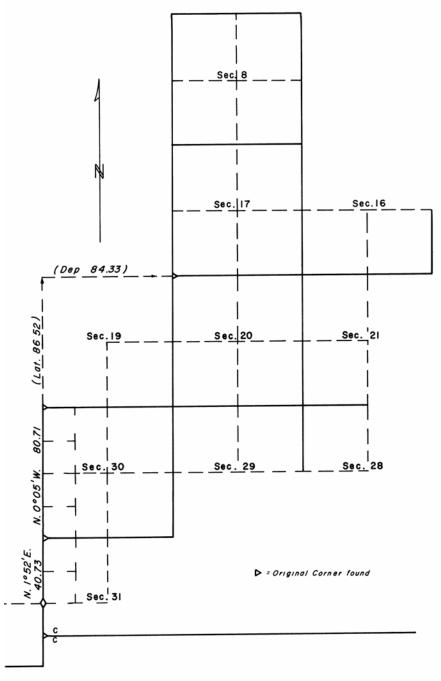
Figure 2 - Corner Recovery

Only four original corners could be found after complete investigation and corner search. The recovered corners, and relationship to each other, are shown in figure 2. The land is mountainous and broken. There are no fences or other improvements.

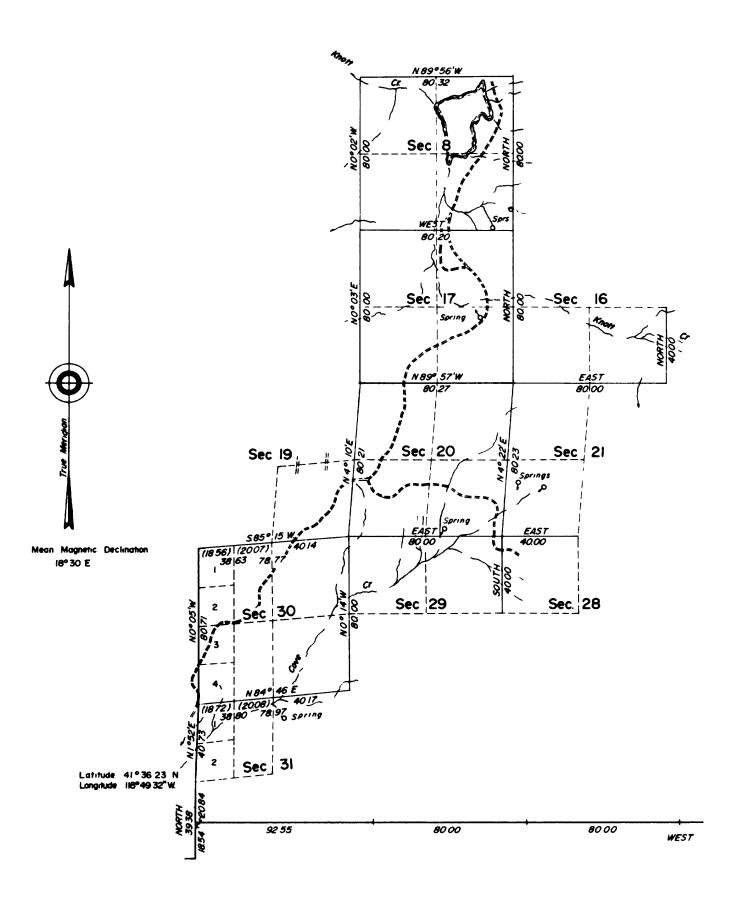
Figure 3 - Accepted Plat

Figure 3 - Detail
